Technical Bulletin

Model
911 C2/C4

Subject: Fuse Ratings Changes

Number
9004

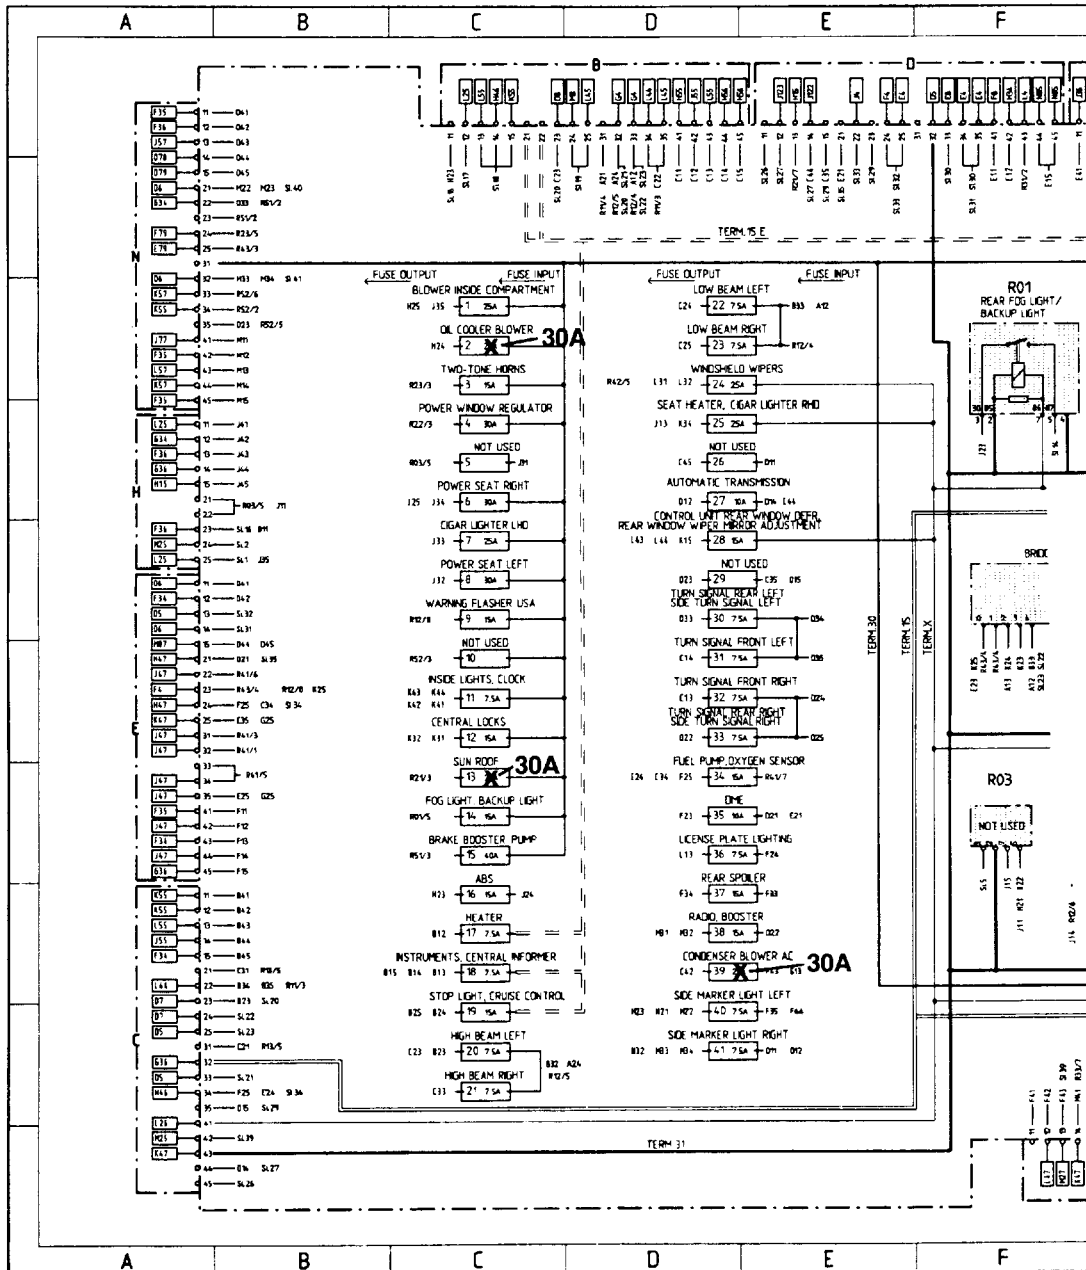
911 Carrera 2/4 Model 90 Sheet 11
CENTRAL ELECTRIC

Concern: The following fuse ratings have been re-evaluated and increased from 25 amp to 30 amp.

Fuse number 2 — Oil cooler blower

Fuse number 13 — Sunroof/Cab top

Fuse number 39 — Condenser blower A/C

Repair Information: Unfavorable tolerance can cause current draws in excess of 25 amp in the above mentioned systems without damage to the electrical wiring. Fuses number 2, 13 and 39 on the central electric board should be replaced with 30 amp fuses (Part Number 999 607 010 00) during repairs on all '89 model year 911 C4 and early production '90 model year 911 C4 and 911 C2.

Please correct your Repair Manual wiring diagrams model year '89 and '90 911 Carrera 2/4, Sheet 11 (see figure on next page). Also the 1990 Wiring Diagram Book (Part Number PNA 000 081) fuse location tab and 911 Carrera 2/4, Sheet 11.
