Technical Bulletin

Subject: Routing and Securing of Electrical Harnesses

Number
8906

PORSCHE CARS NORTH AMERICA - INC.

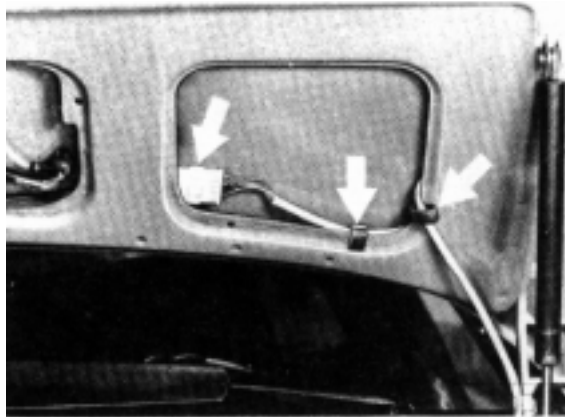
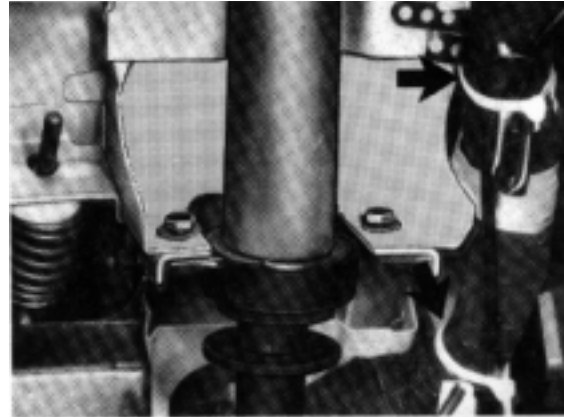
When working on a vehicle, it is often necessary to move and/or disconnect a wiring harness to facilitate repairs. When reinstalling such a harness, it is absolutely necessary to properly route and fasten it. The routing and installation of wiring harnesses in Porsche vehicles is carefully designed to prevent any contact with other parts of the vehicle that have the potential to damage the harness; therefore, the reinstallation must duplicate the original installation. All wire ties and harness clips should be attached in their original location. All electrical plugs and connectors should be checked to ensure proper engagement. Any insulation pads, bushings, grommets, shields and/or covers removed during repairs must be reinstalled in their original location and in a manner that will not damage the harness or related components.

Failure to properly route and secure a wiring harness after repair can result in unwanted squeaks, rattles or damage to the harness and other parts of the vehicle electrical system. Damage to the harness, if undetected, may result in short circuits and under some circumstances may result in an electrical fire.
